## **Role of fire resistance issues in the first ever collapse of a steel-framed building - WTC 7**

**Kodur, V.K.R.**

**NRCC-46279**

**A version of this document is published in / Une version de ce document se trouve dans :  
CIB World Building Congress 2004, Toronto, ON., May 1, 2004**

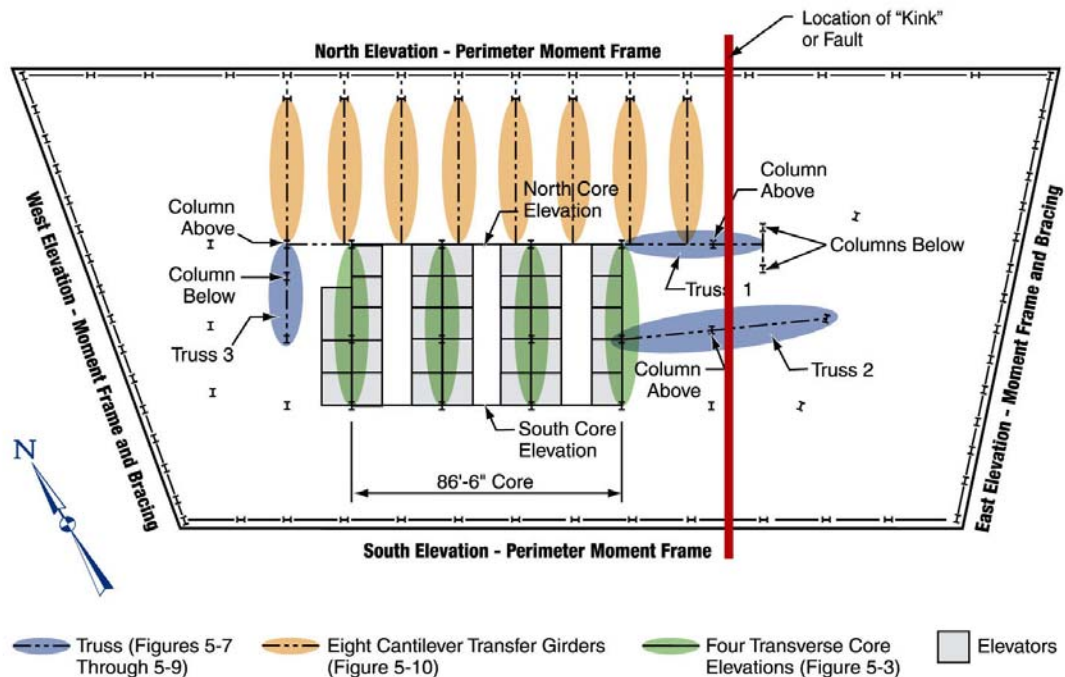
**Figure 2 Area of potential transfer truss failure in WTC 7**

Finally, at about 5:20 p.m., the collapse sequence was initiated in WTC 7. First, the penthouse on the east side of the roof disappeared from view, then about 10 seconds later the penthouse on the west side disappeared. Subsequent to the disappearance of the west penthouse, the progressive collapse started, apparently on a lower floor. Videotape records of the collapse from the news media clearly indicate that the upper 30 to 35 stories appear to descend intact, indicating the collapse was initiated on a lower floor. In addition, just prior to the collapse, a crack or “kink” or fault line (FEMA 2002) develops along the north wall in the vicinity of the east penthouse located over transfer trusses 1 and 2 on the eastern side (see Figure 2).

One proposed mechanism of the collapse was a failure of transfer truss 1 or 2 due to fire exposure on that level. Fuel loads were reportedly light in the vicinity of the trusses except for pipes carrying diesel fuel to and from the generators (Milke 2003). While some fuel was found in the underground tanks once they were recovered, the exact role of the diesel fuel is not fully clear at this time.

A review of the WTC 7 collapse indicates that the progressive collapse was initiated on a lower floor level and that the upper 30 to 35 stories descend intact (FEMA 2003). In addition, just prior to collapse, a crack or "kink" or fault line (FEMA 2002) develops along the north wall in the vicinity of the east penthouse on the eastern side. The east penthouse is located over transfer trusses 1 and 2.

One of the possible collapse mechanisms is the failure of transfer truss 1 or 2 due to severe fire exposure on that level. These huge steel transfer trusses were critical elements in WTC 7 and ran mostly through the 5th, 6th and 7th floors where the fires burned towards the end. As the fires burned uncontrolled, at the lower floors, and raised the temperatures of structural members over a period of many minutes, this induced additional stresses into the damaged structural frames, while simultaneously softening and weakening these frames. The failure of these critical elements (due to massive fires) had a significant impact on the overall structural system and must have initiated the progressive collapse. Thus, the full collapse of the 47-storey

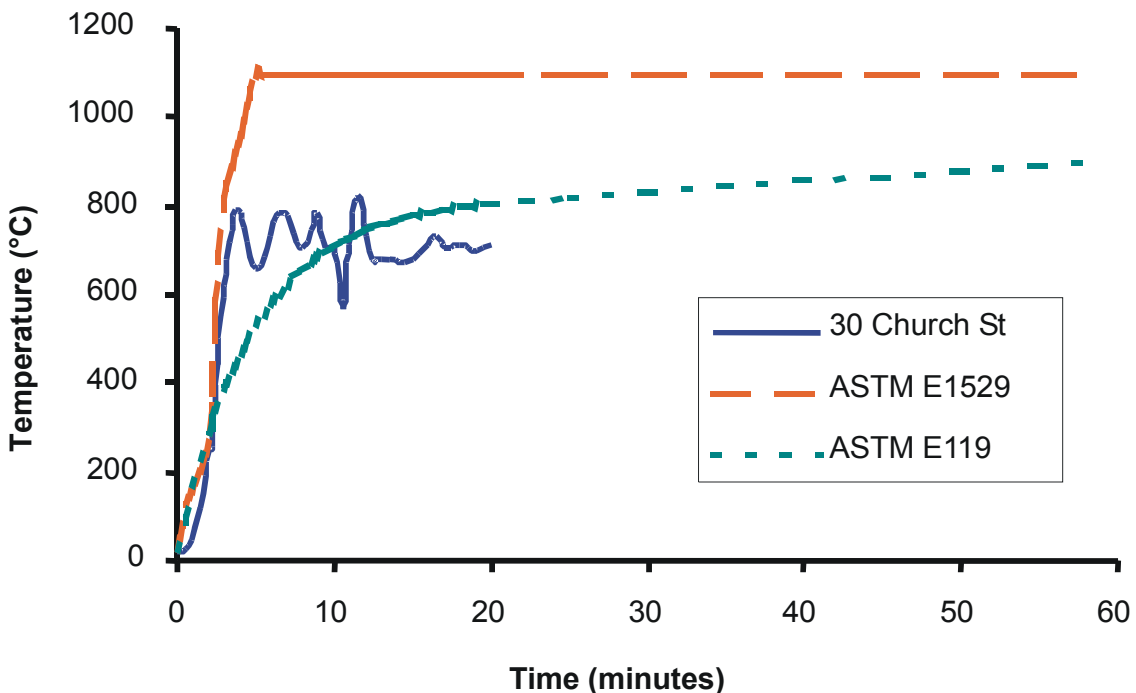
The simultaneous fires across several floors at the same time generated fire conditions significantly more severe than those anticipated in typical building fires (FEMA 2002). The maximum fire temperatures attained in the WTC 7 fires were in the range of 1,000° to 1,100°C. In Figure 3, the time-temperature curves from two standard tests and typical building fires based on temperature measurements acquired in experiments involving office furnishing conducted by DeCicco, et al., (1972) in the Hudson Terminal Building (30 Church Street, New York), is compared. Temperature development in the WTC 7 fires in the later stages is likely to be closer to the ASTM E-1529 curve.

**Figure 3** Time-Temperature curves from two standard tests and temperature measurements (DeCicco, et al., 1972) in the Hudson Terminal Building

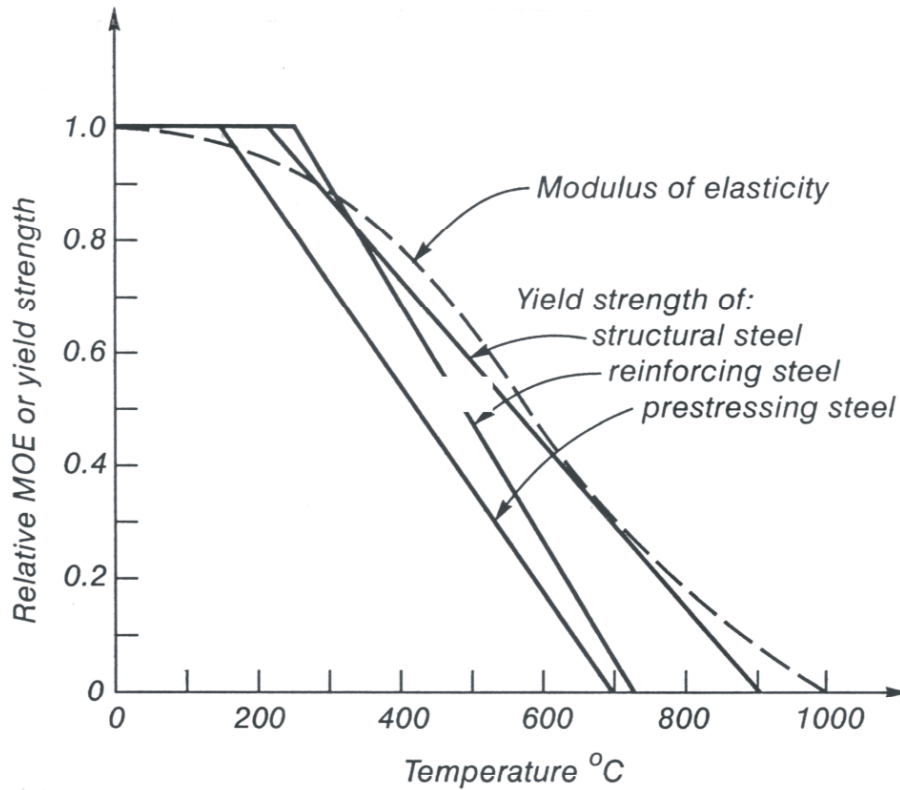
This continuous burning of fires at multiple floors weakened the structural system of WTC 7 at some levels. Steel loses its strength and stiffness when subjected to high temperatures. A typical steel structural member loses its load-carrying capacity (or about 50 percent of its original strength) at 538°C (1,000°F) when exposed to an ASTM E-119 standard fire (Kodur and Harmathy 2002). An unprotected steel member subjected to an ASTM E-119 standard heating environment is able to maintain its structural integrity for about 20 minutes. To limit this loss of strength and stiffness, external fire protection (fire proofing) is provided to the steel structural members to achieve the required fire resistance ratings. Figure 4 illustrates the variation of strength and stiffness in steel as a function of temperature. In the case of WTC 7, the fire scenario might have been more severe than an ASTM E-119 standard fire that is often used as a bench mark for building fires. In addition, the fires were burning on multiple floors simultaneously. The impact of the temperature on the structural members became a function of the thermal properties of the fire proofing and the "heat sink" of each structural member.

**Figure 4** Variation of strength and modulus of elasticity of steel with temperature

Contrary to some reports, the steel did not melt. The melting point for steel varies with the alloy and is in the range of 1,500-1,600°C. Since the fire temperatures did not reach this value it is unlikely that there was any melting of steel.
